PBIC Livable Communities Webinar Series

Federal Highway Administration Pedestrian Safety Guidance for Transit

Dan Nabors
Vanasse Hangen Brustlin, Inc.

September 23, 2009

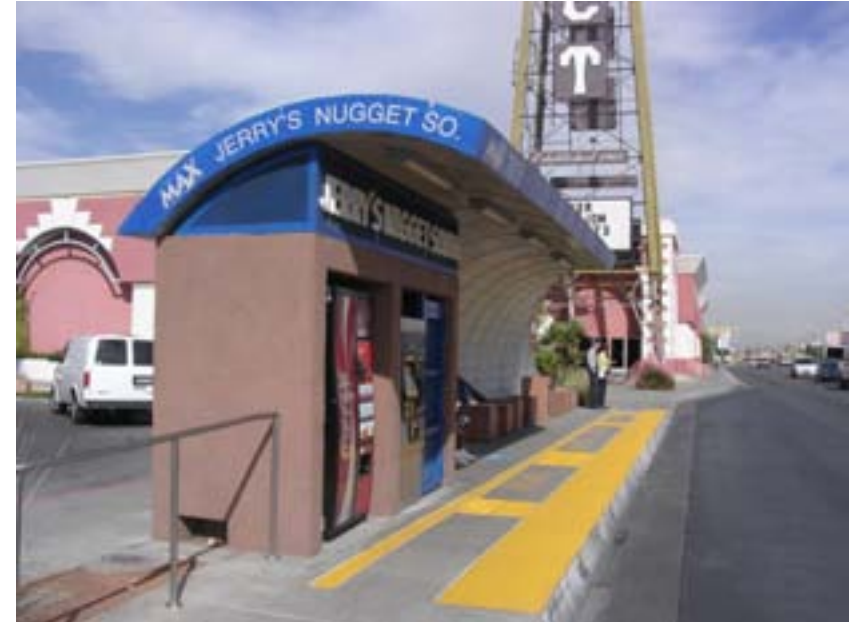
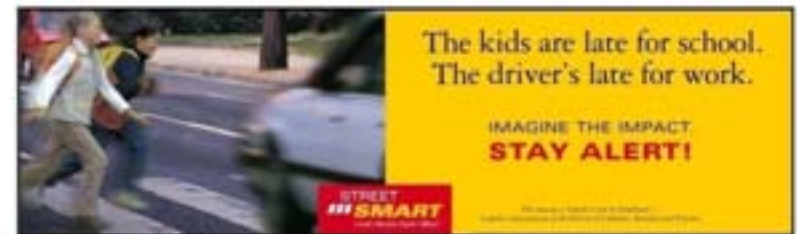
Posters displayed on WMATA buses as part of the StreetSmart Campaign in the Washington, DC region. Source: StreetSmart public safety program of the District of Columbia, Maryland, and Virginia.

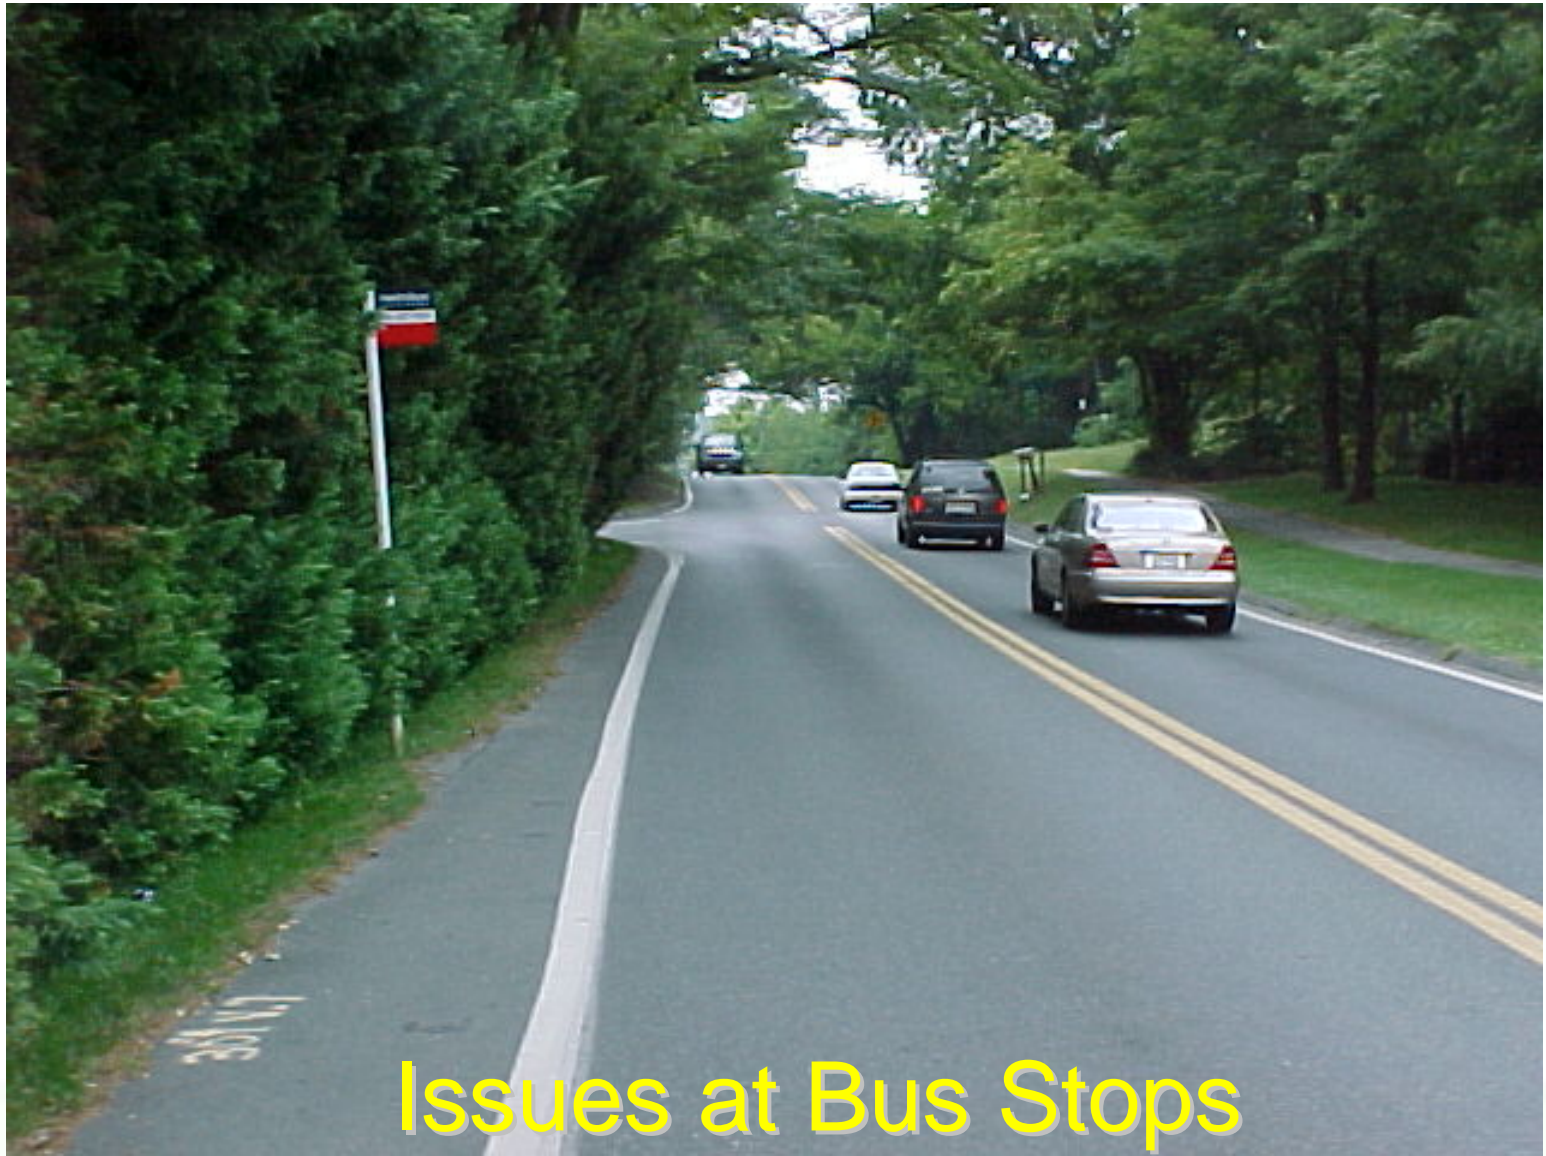
Issues at Bus Stops

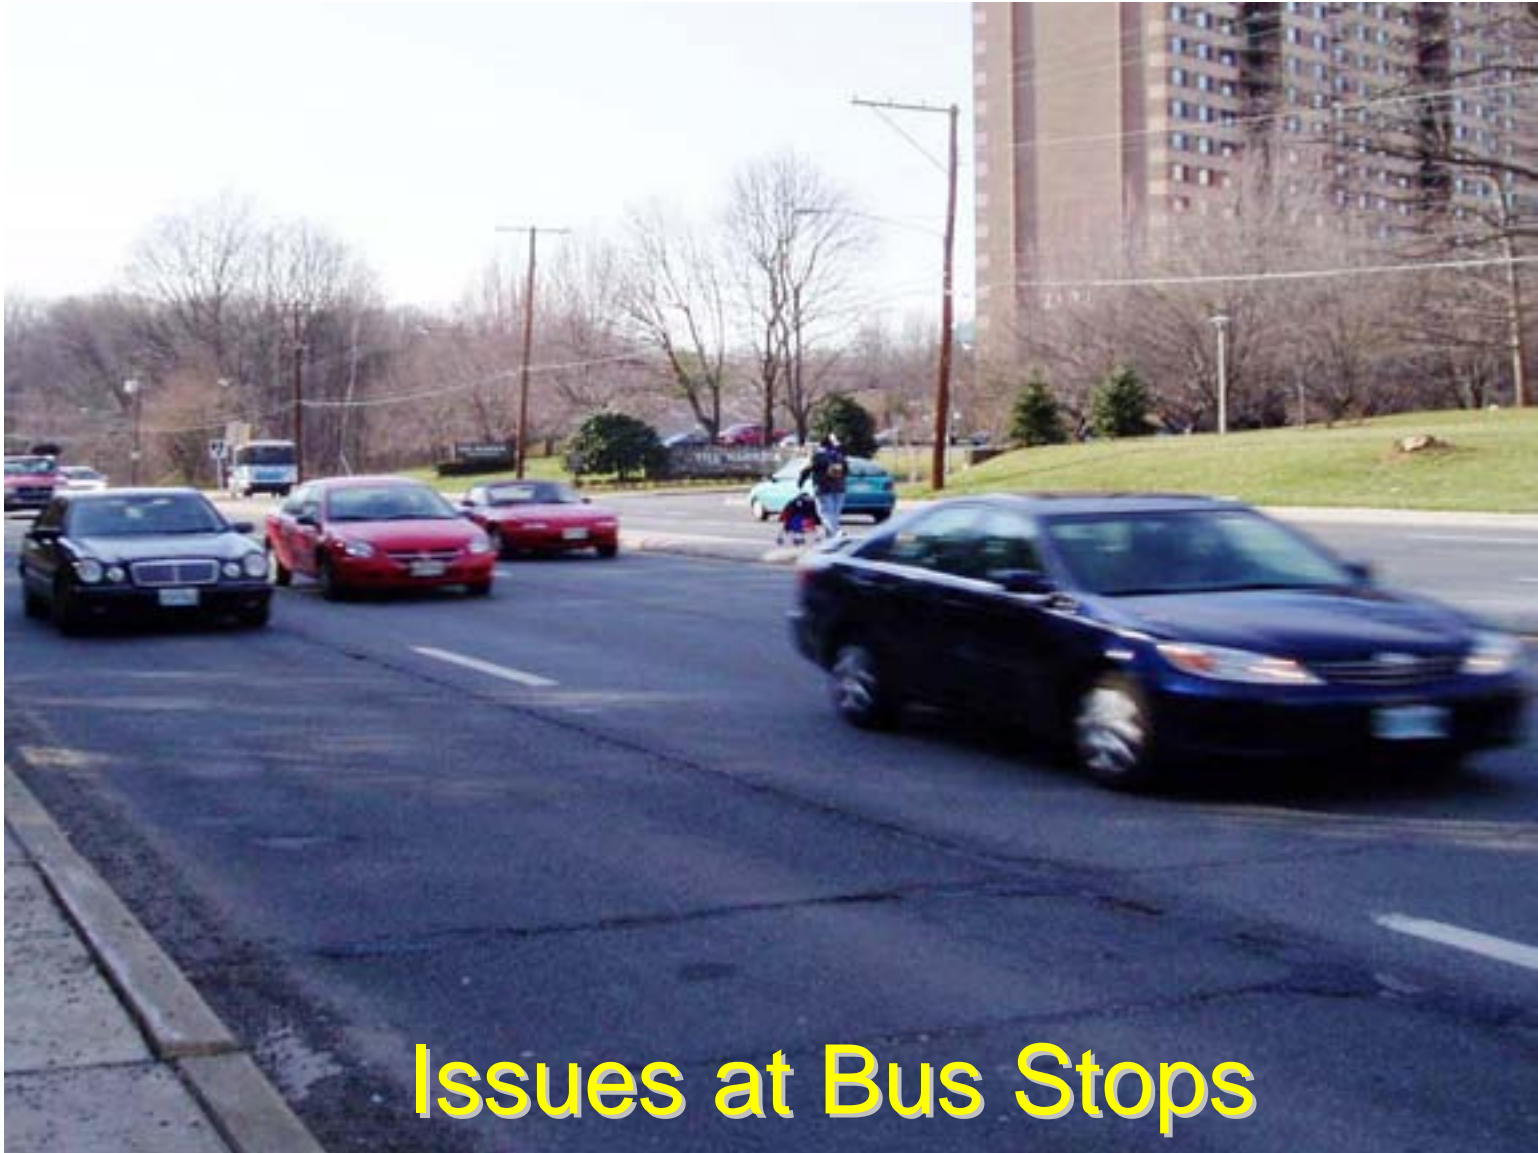
Issues at Bus Stops

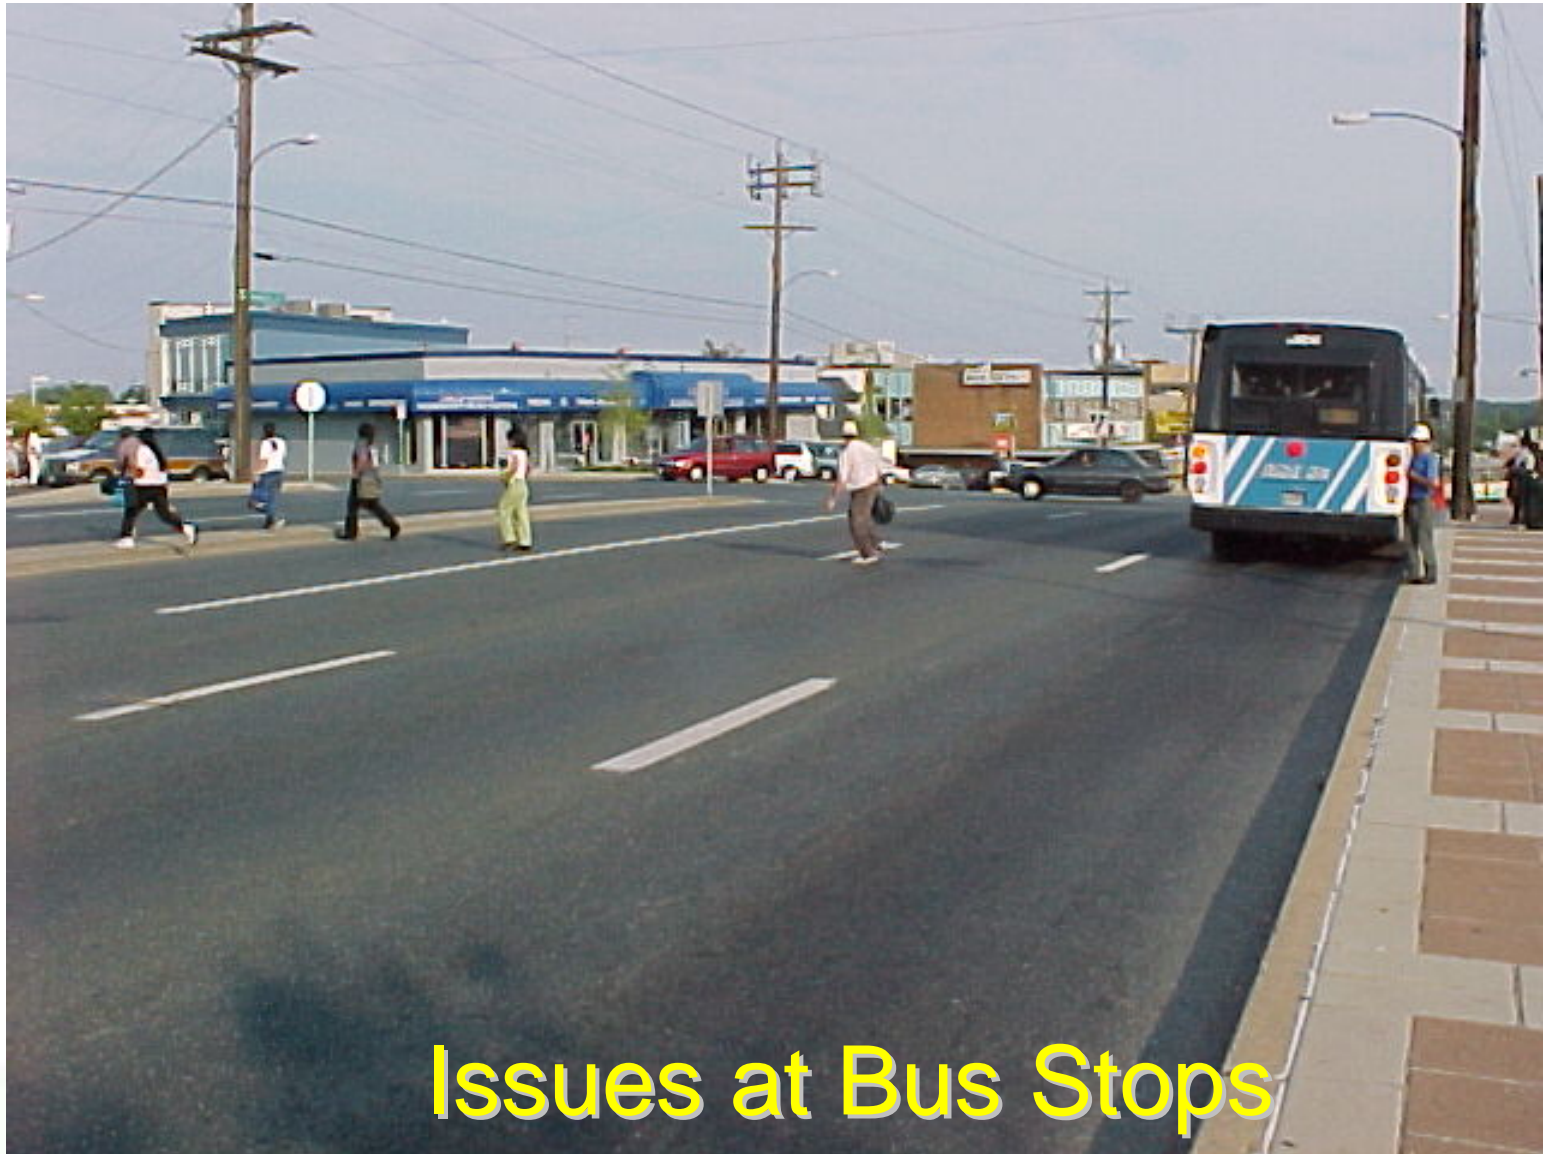
Issues at Bus Stops

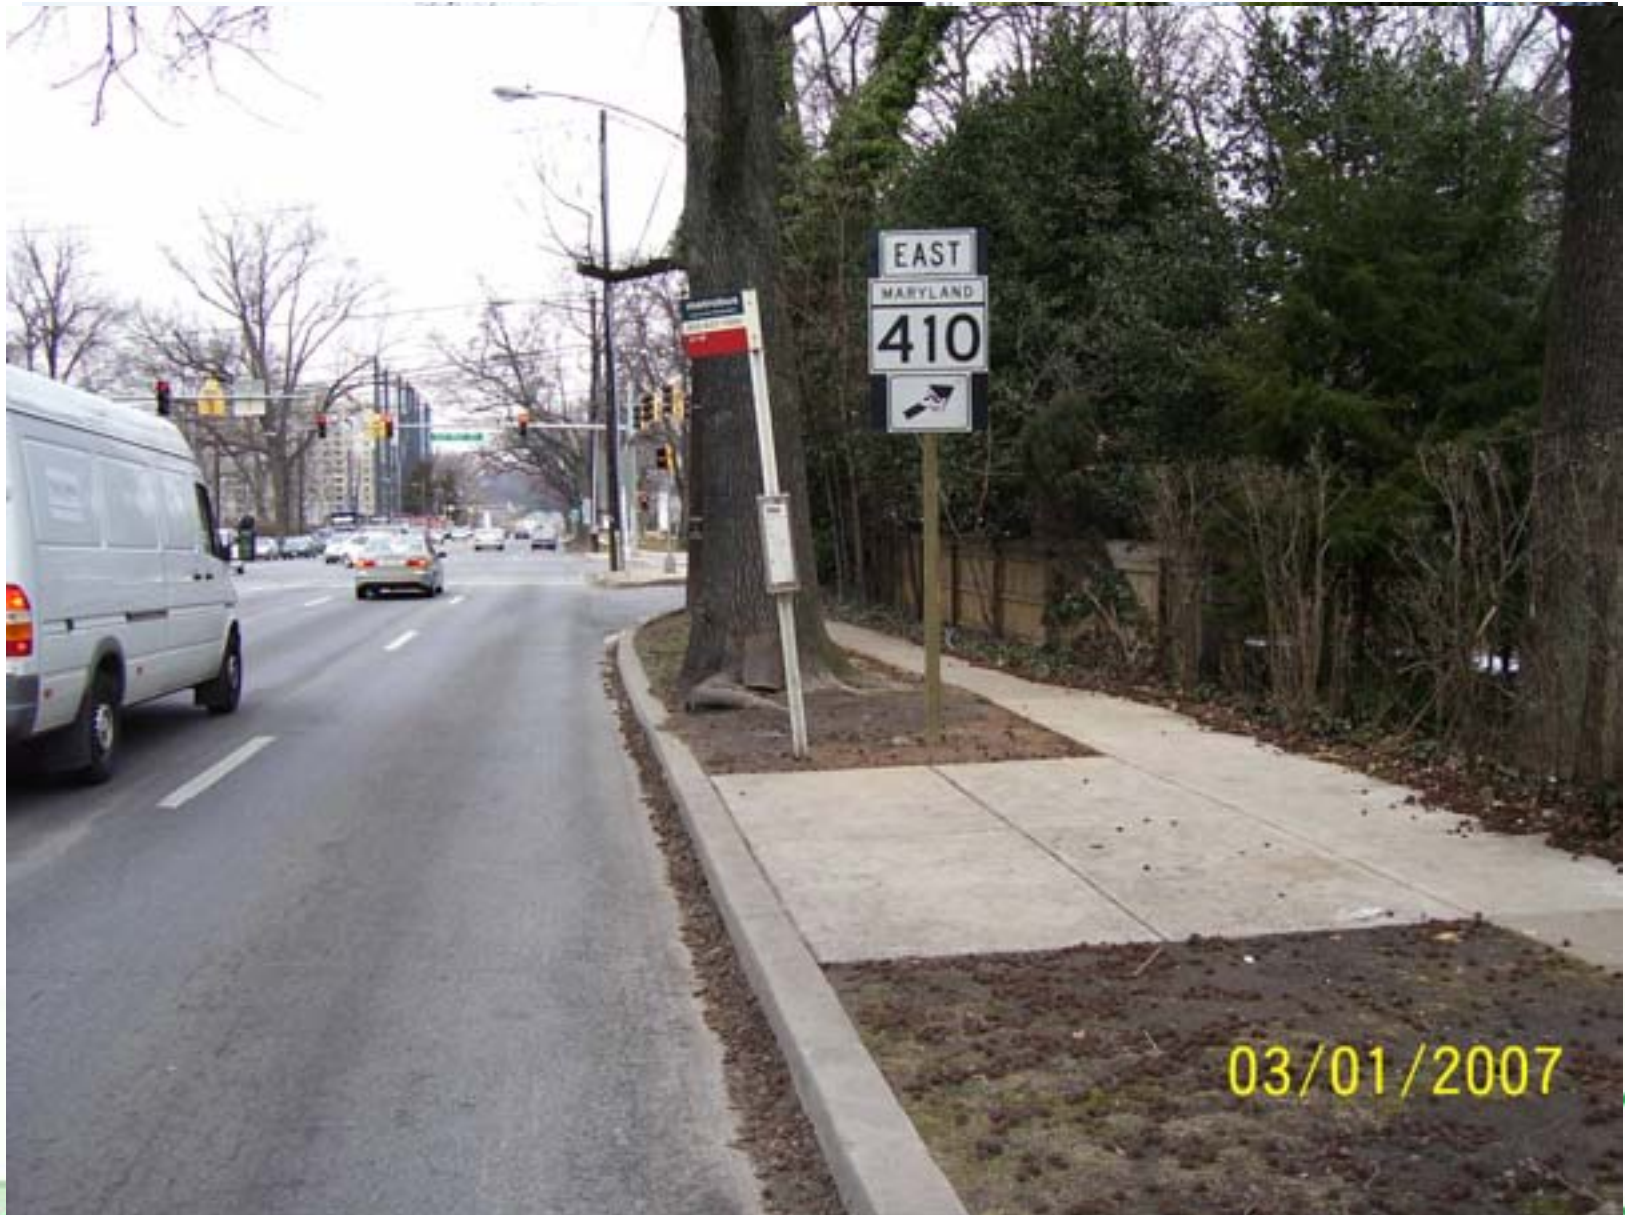
Before and After → Reverse Bulb-out Intersection Improvement

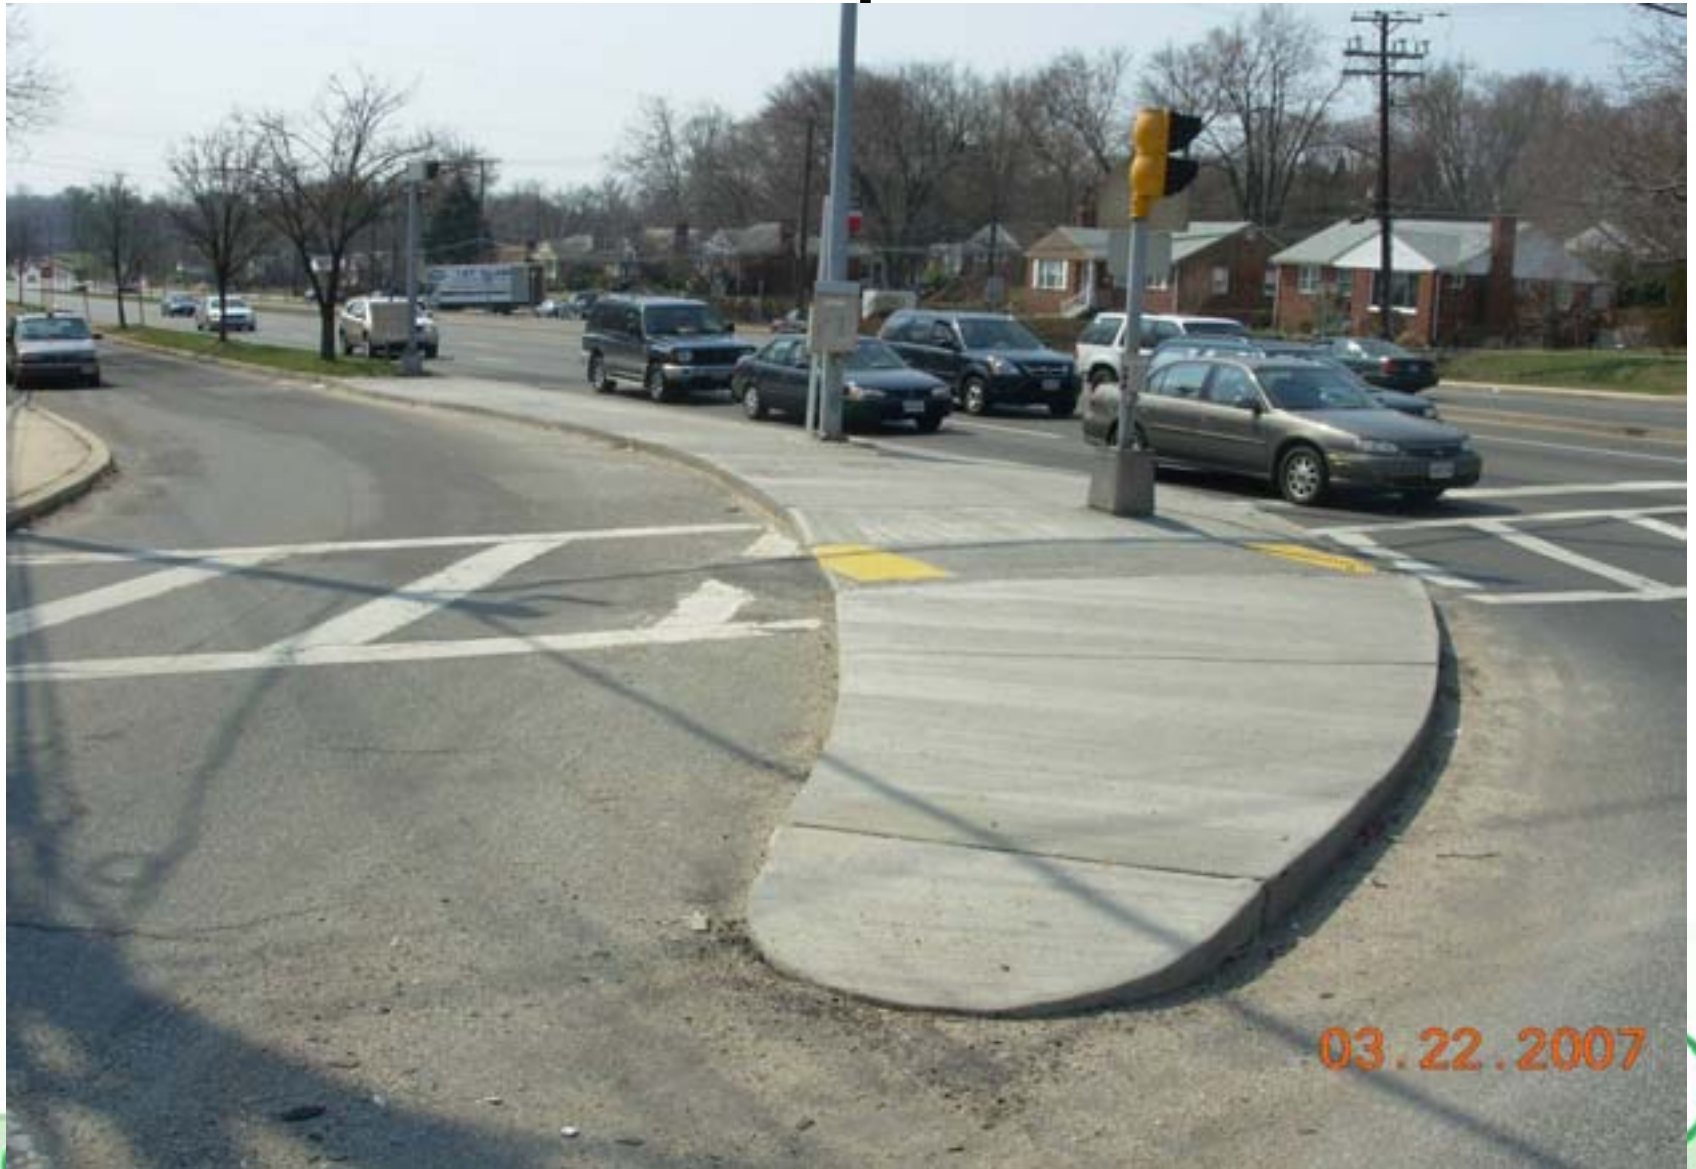
Before and After → ADA Access

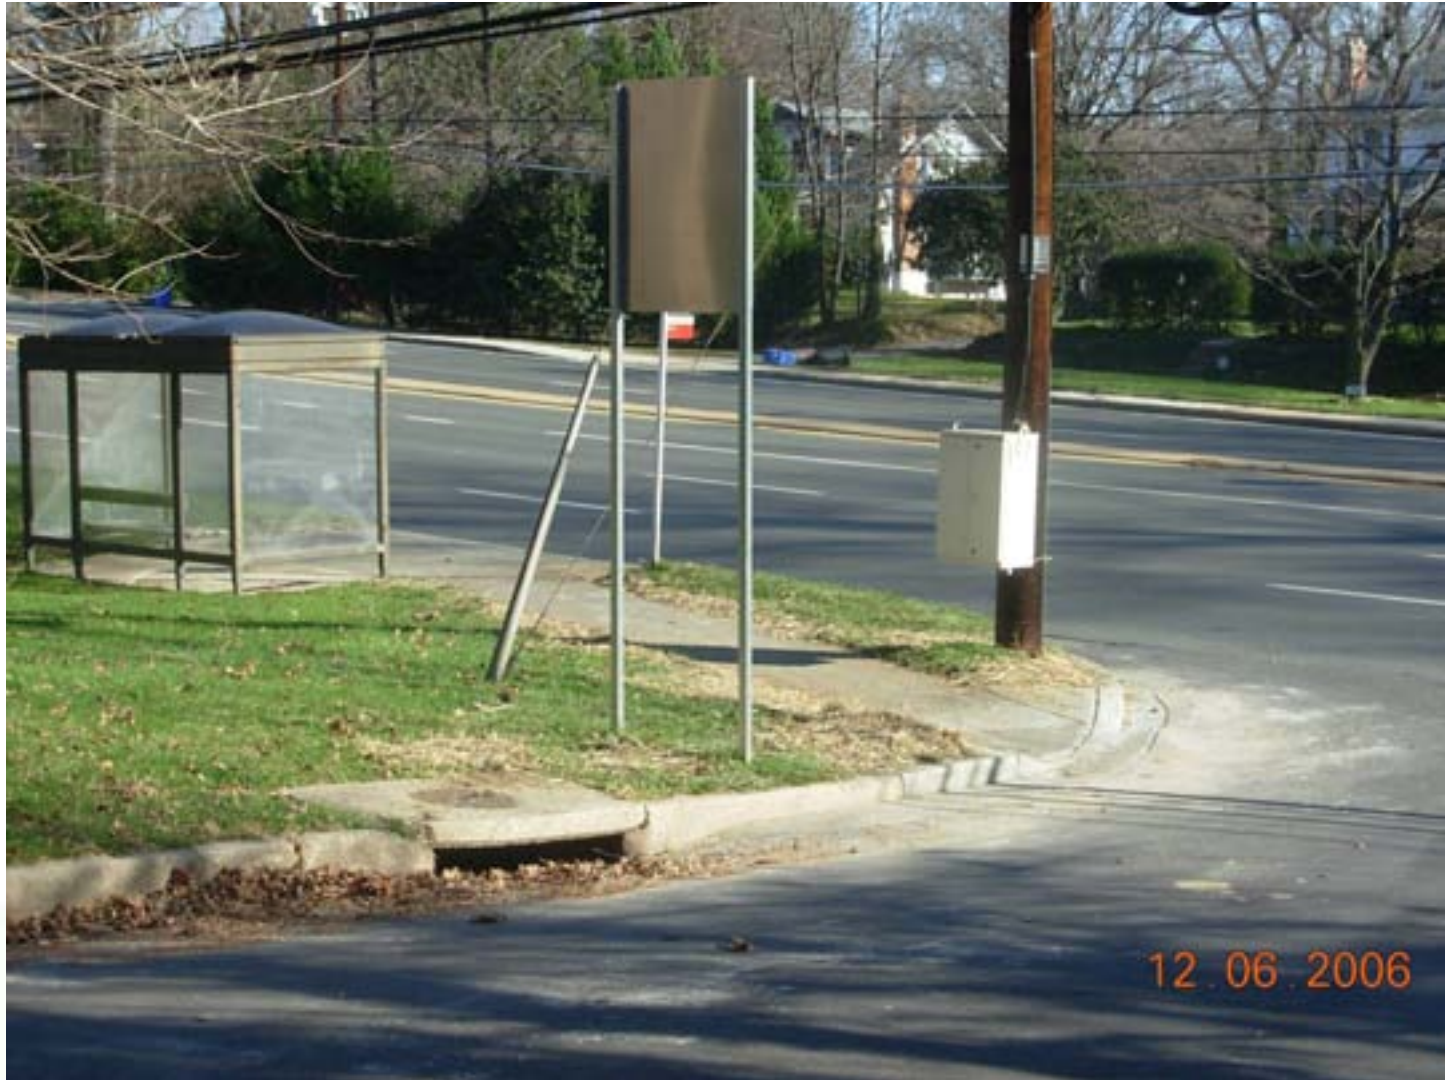
Before and After → Pad & Knee Wall

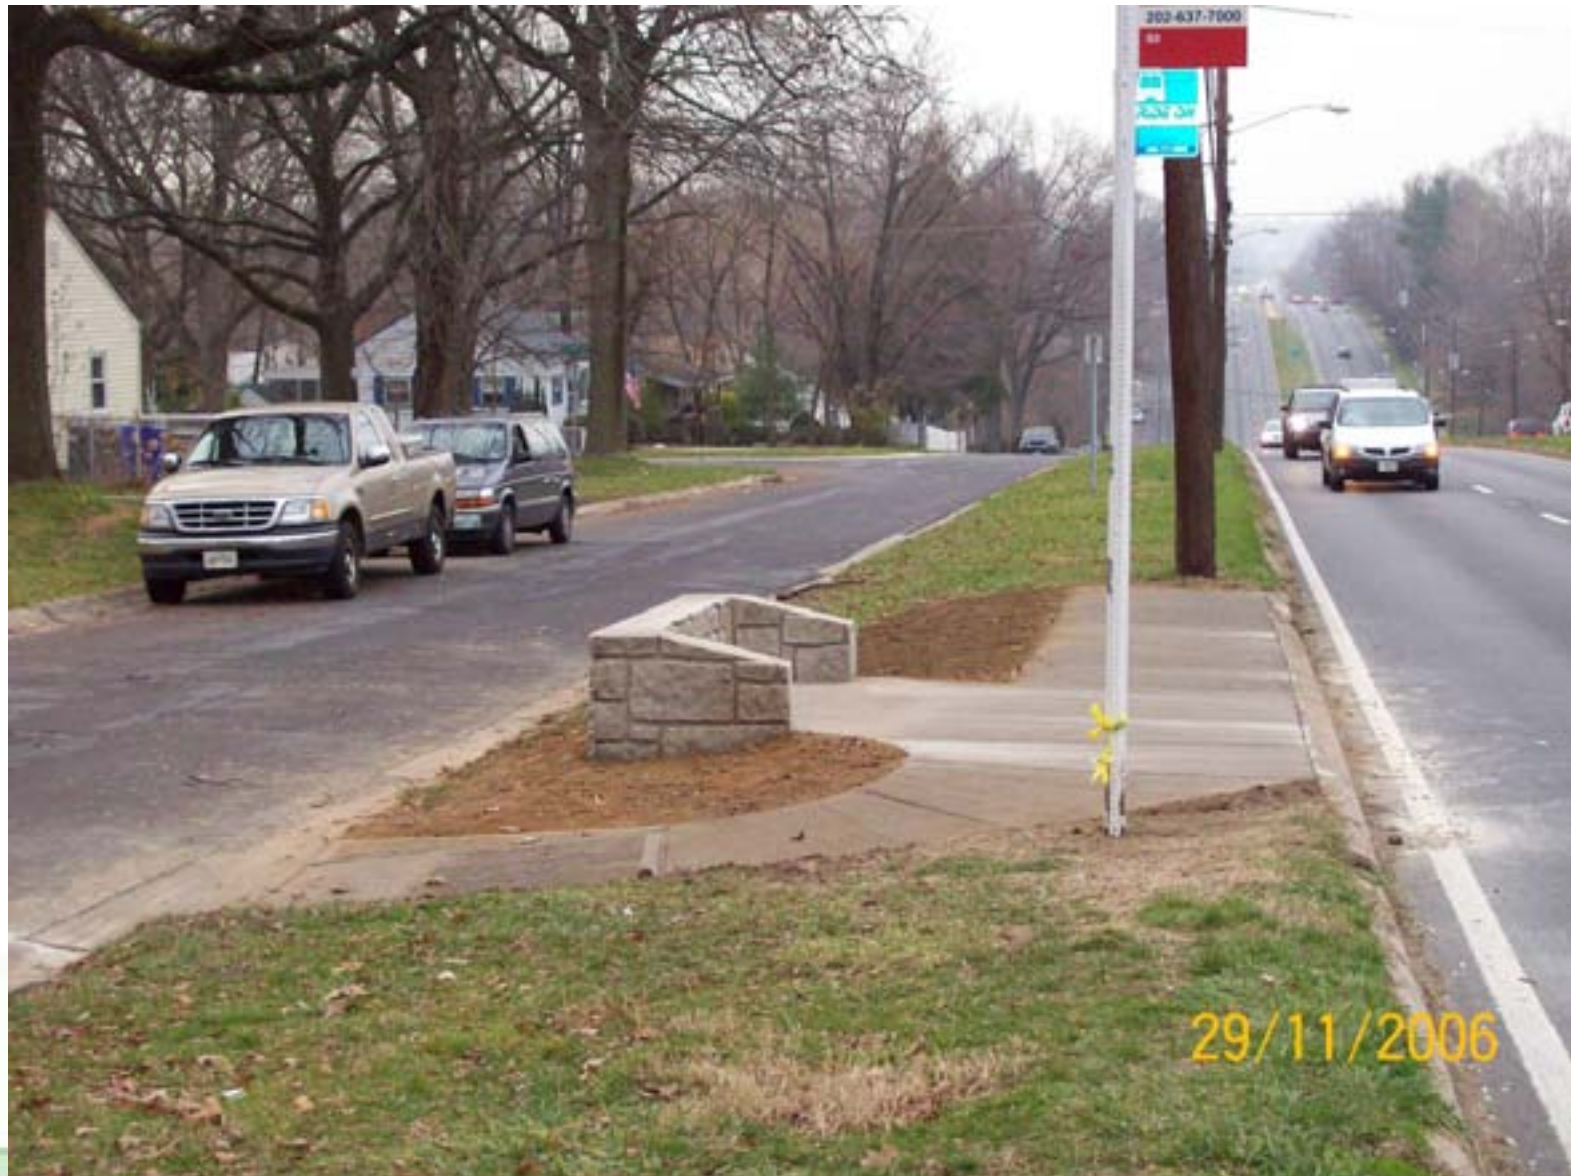
Before and After → Ped Refuge Island
