Pedestrian Safety and Accessibility Considerations at Modern Roundabouts

Institute for Transportation Research and Education (ITRE) at North Carolina State University

Safety and Design Technical Service Team, FHWA Resource Center

March 7, 2012

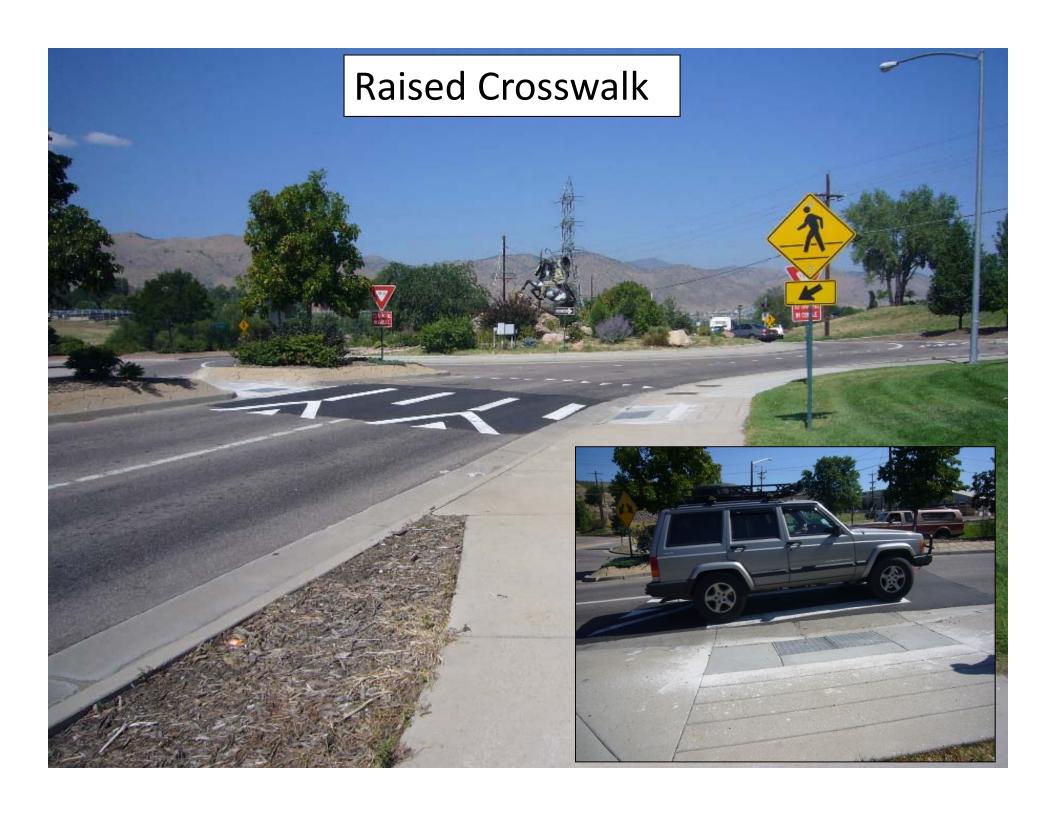
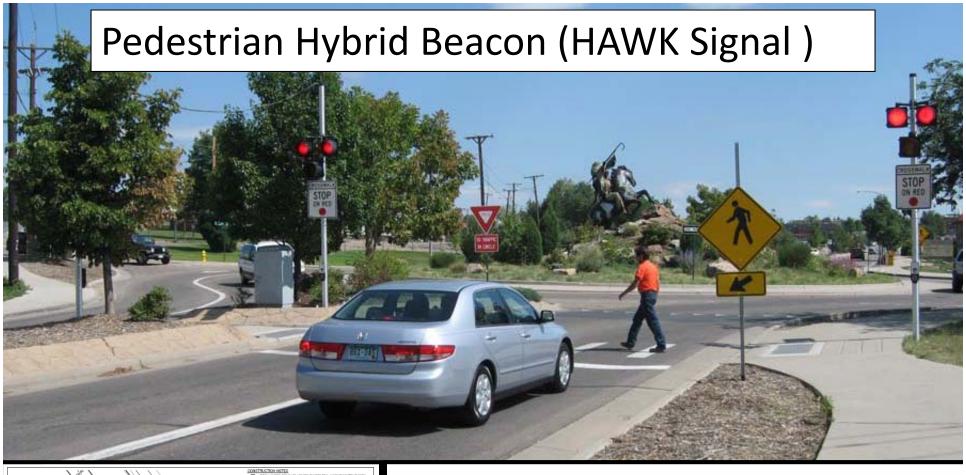
Figure 4F-3. Sequence for a Pedestrian Hybrid Signal

1. Dark Until Activated

2. Flashing Yellow Upon Activation

3. Steady Yellow

4. Steady Red During Pedestrian Walk Interval

Alternating Flashing Red During Pedestrian Clearance Interval

6. Dark Again Until Activated

- Raised Crosswalk
 - Average delay decreased (17 sec to 8 sec)
 - 85th percentile delay decreased (30 sec to 13 sec)
 - O&M interventions decreased (2.8% to 0%)
 - ... but some "risky" events observed
- Pedestrian Hybrid Beacon
 - Average delay decreased (16 sec to 6 sec)
 - 85th percentile delay decreased (30 sec to 8 sec)
 - O&M interventions decrease (2.4% to 0%)
 - ...but high vehicle red-light violations (12.6%)

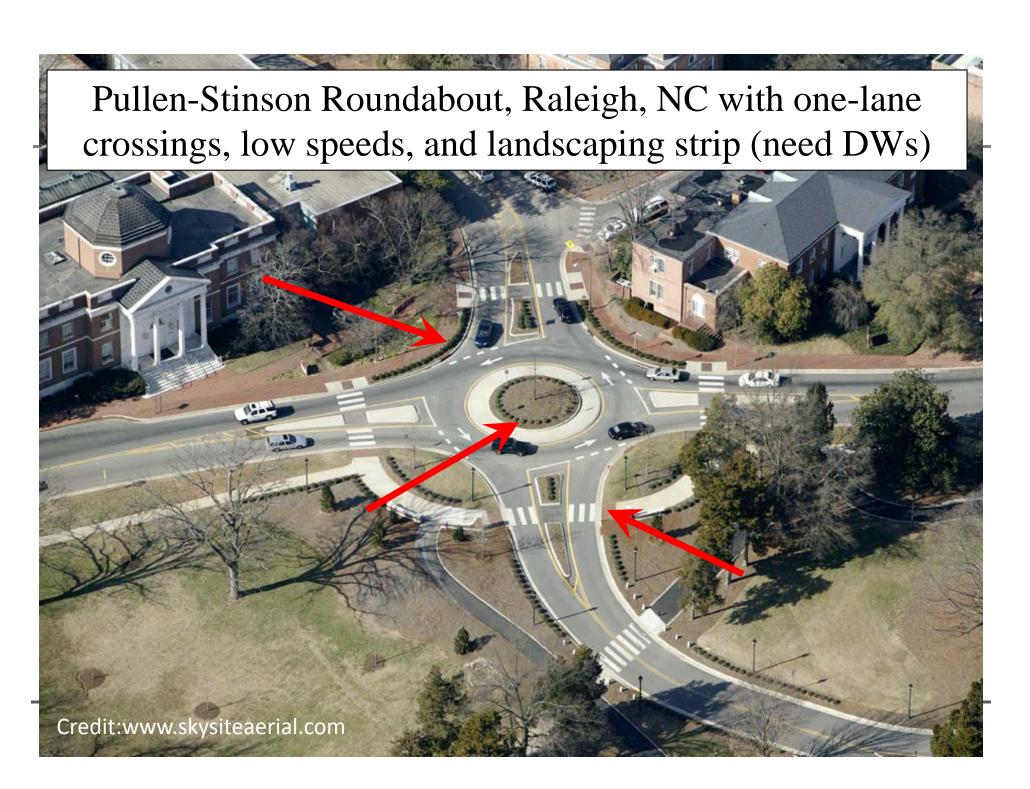
Two-lane roundabout in Gatineau, Canada with *zig-zag* signalized crossing and landscaping that guides to crosswalk (need DWs)

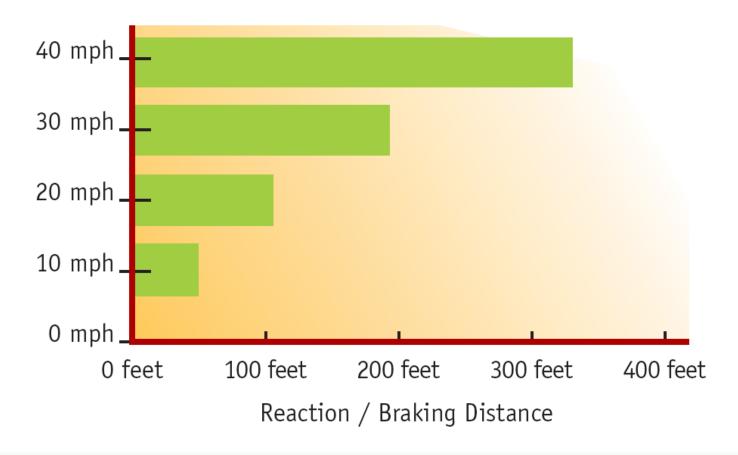
High speeds equate to greater reaction and stopping distance

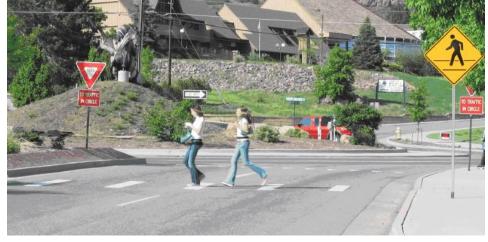
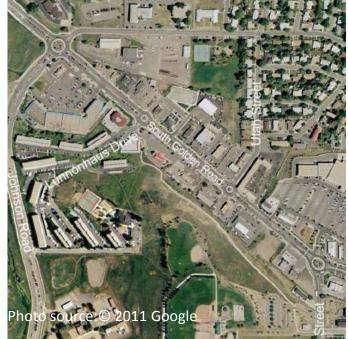
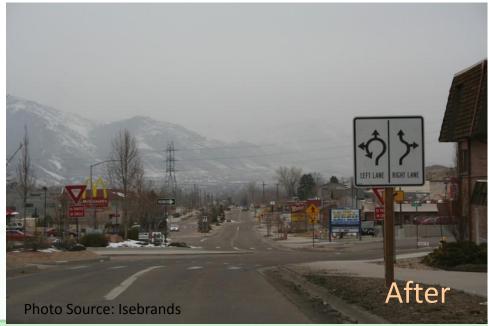
South Golden Road - Golden, Colorado

BEFORE		AFTER
47 mph	85 th Percentile Speeds	33 mph
53 (3 yrs)	Total Crashes/Yr (Ave)	30 (5 yrs)
10 (3 yrs)	Injury Crashes/Yr (Ave)	1.8 (5 yrs)
