Route 71 Pedestrian Tunnel at Monmouth University

Pedestrian and Bicycle
Information Center

Route 71 Pedestrian Tunnel at Monmouth University—West Long Branch, NJ

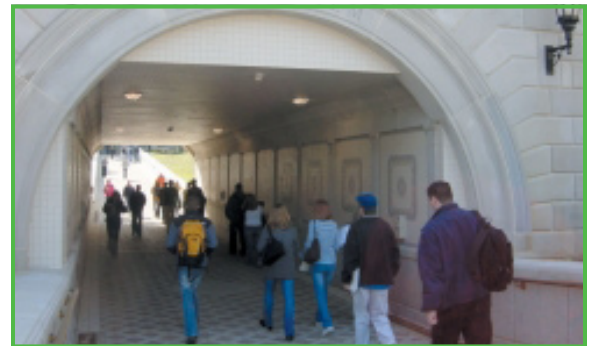
Students walking through the tunnel.

Student safety, drainage, impact to the existing historic area, and construction were all concerns dealing with the pedestrian underpass. The safety issues were addressed with a security system that is linked to campus police; drainage problems were solved with a pump and underground storage system; architectural treatments were enhanced to blend with the historic context; and constructability issues were solved by a structural design approach aimed at minimizing impacts. The ramps that approached the tunnel were designed to meet Americans with Disabilities Act (ADA) standards with specific grade, landing area, and cross slope requirements. The tunnel width was 14 feet, the height was 10 feet (to accommodate university maintenance vehicles), and the length was 71.5 feet.
